NAVAL POSTGRADUATE SCHOOL

THESIS

**CORROSION AND THERMAL PROCESSING IN COLD
GAS DYNAMIC SPRAY DEPOSITED AUSTENITIC
STAINLESS STEEL COATINGS**

June 2016

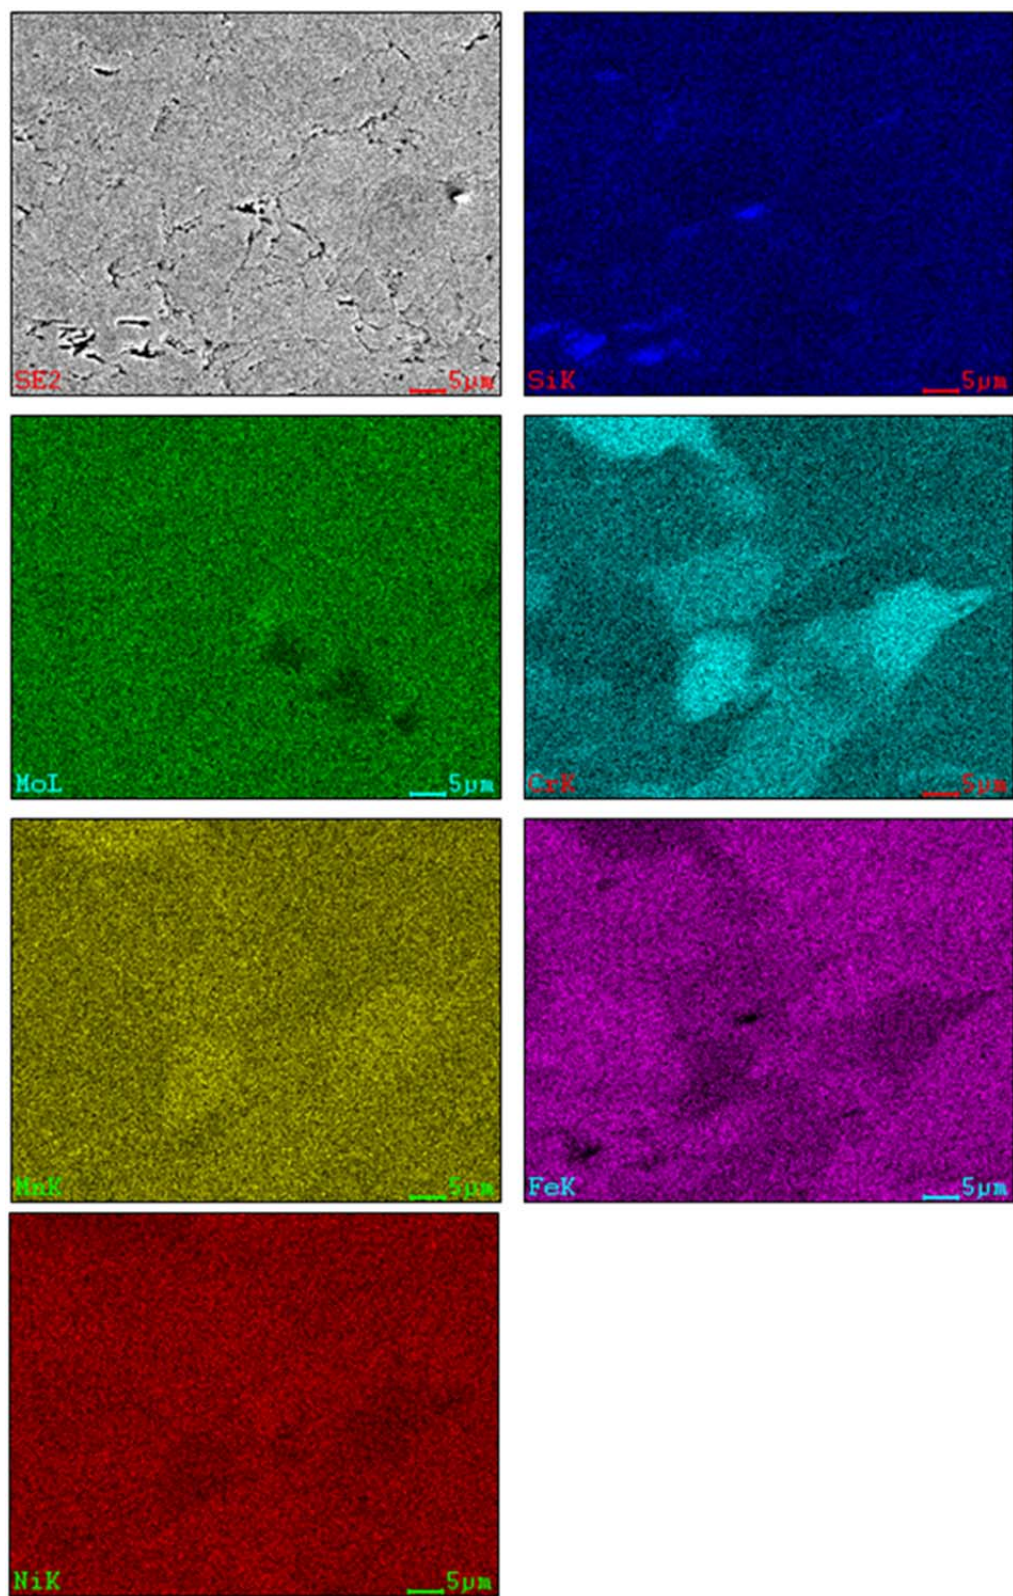
Figure 78. EDS Maps of as sprayed PG-AMP-10 powder.

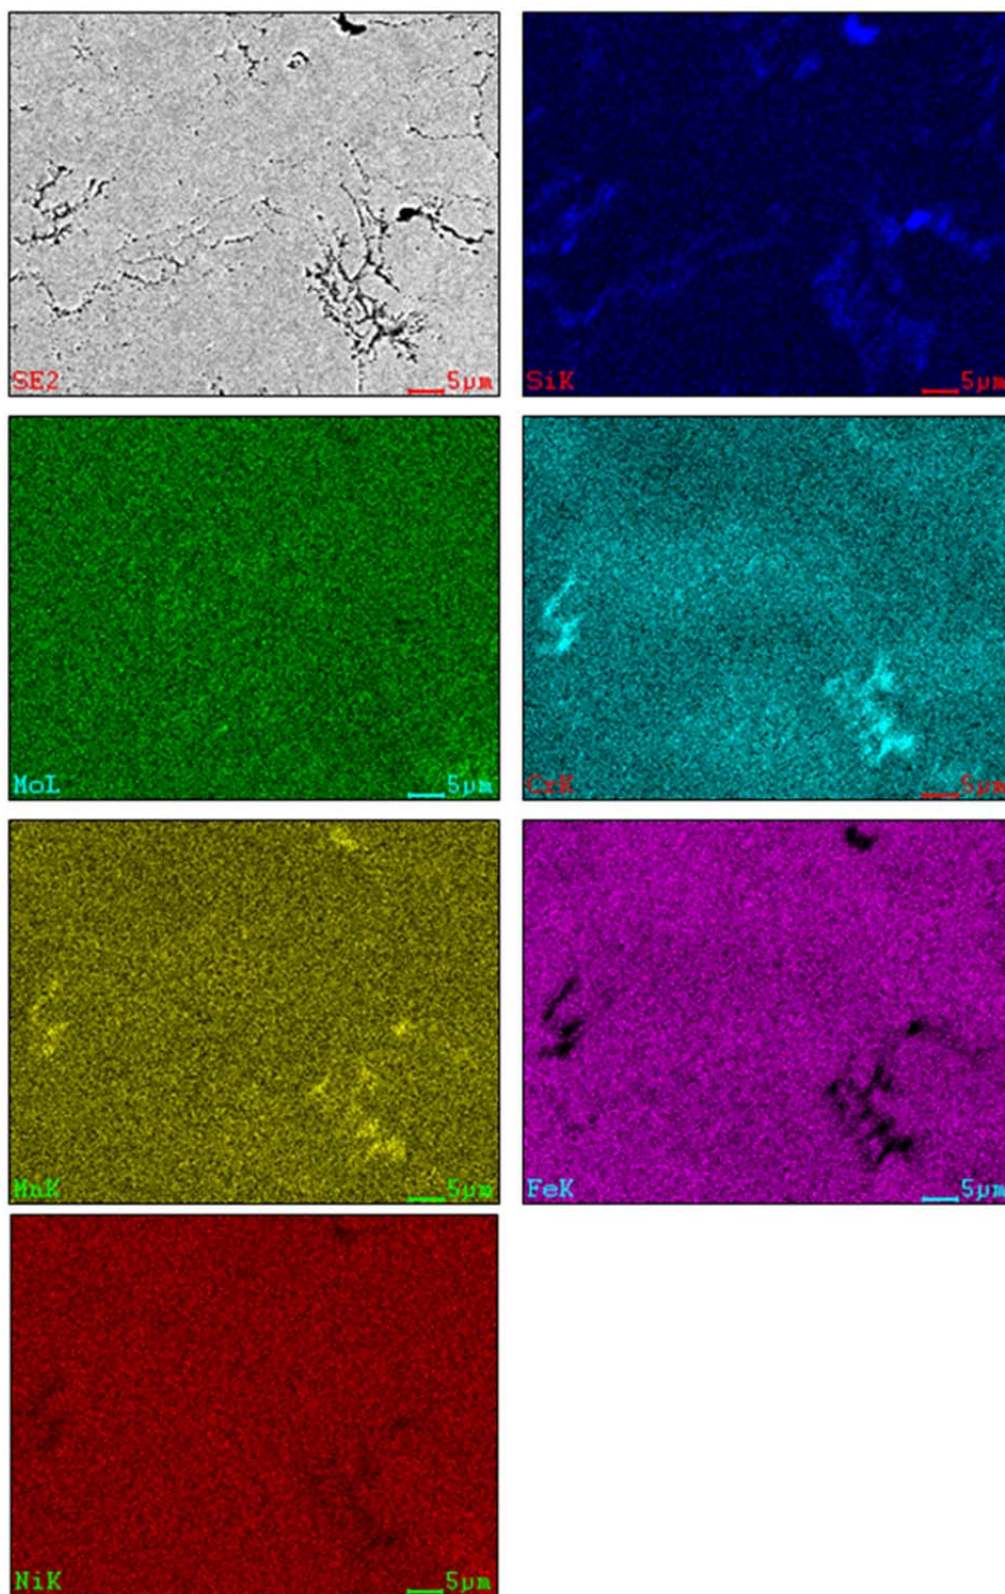
Figure 79. EDS Maps of PG-AMP-10 powder, 950°C/1 hr heat treatment.

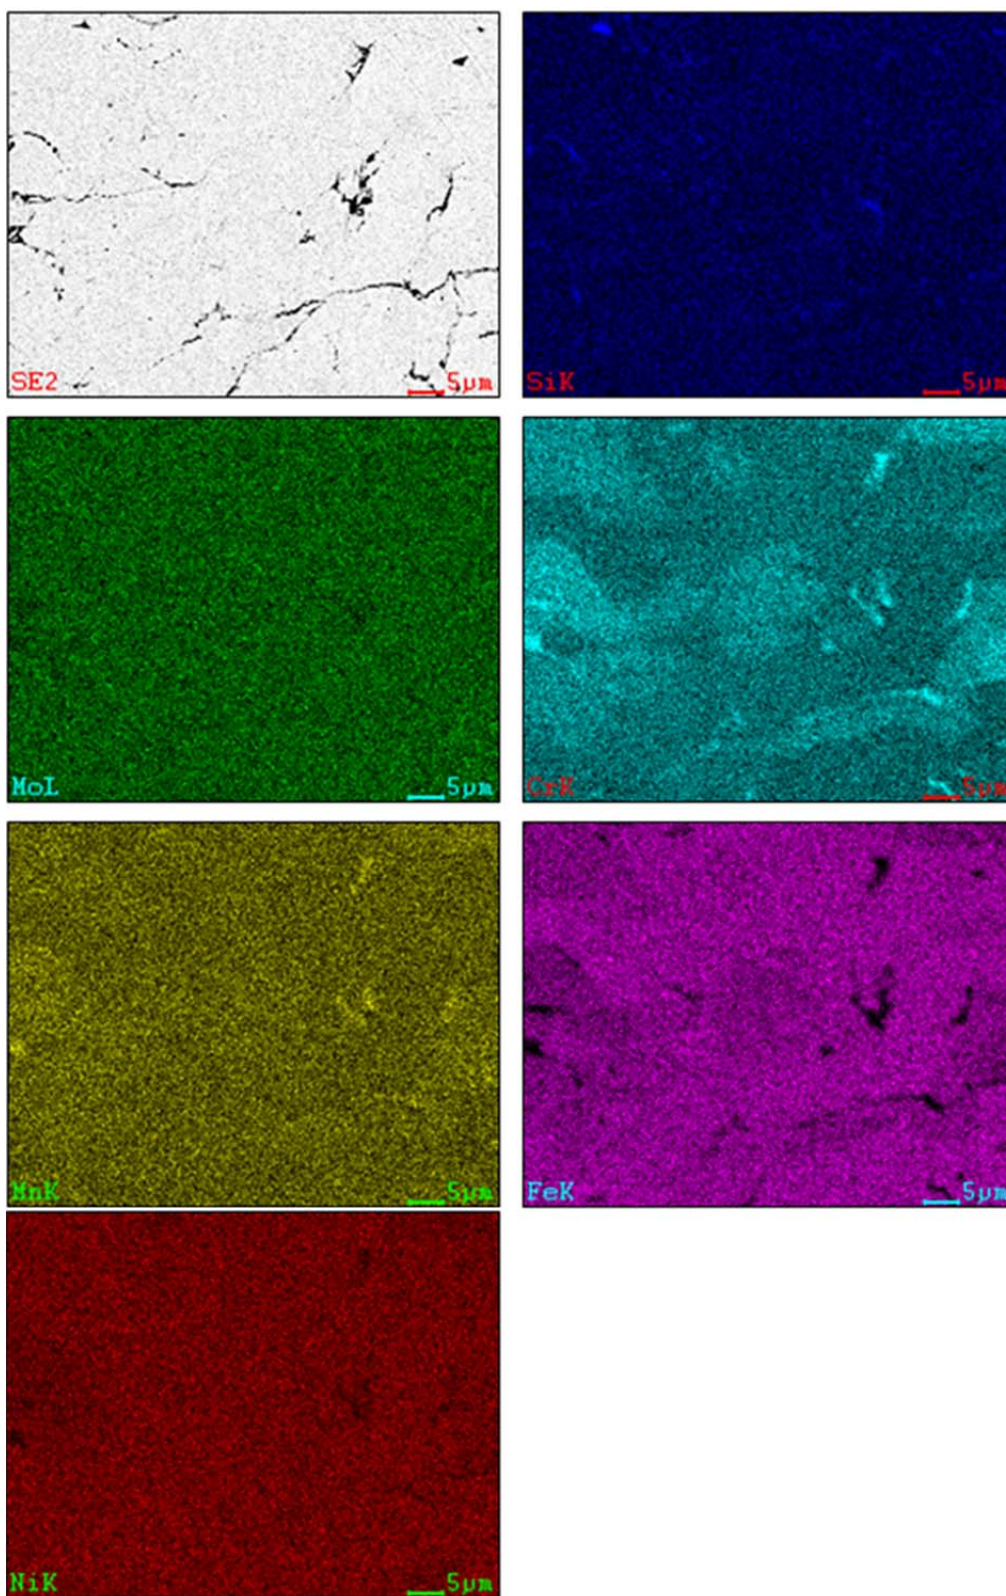
Figure 80. EDS Maps of PG-AMP-10 powder, 800°C/2 hrs heat treatment.

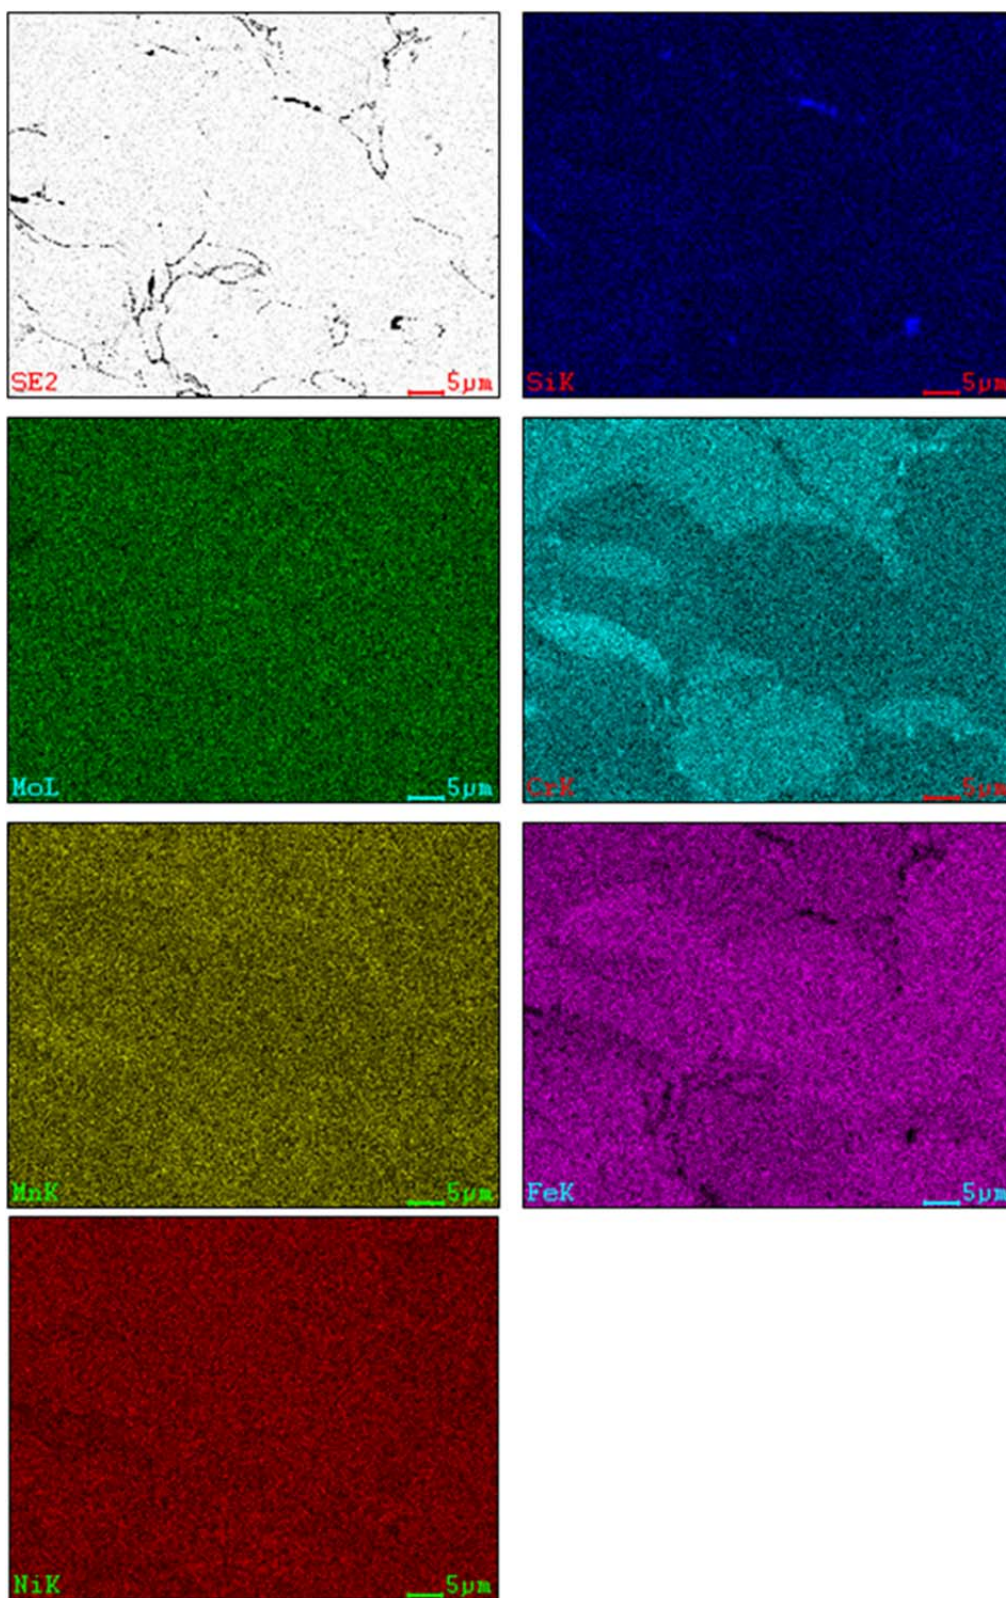
Figure 81. EDS Maps of PG-AMP-10 powder, 600°C/8 hrs heat treatment.

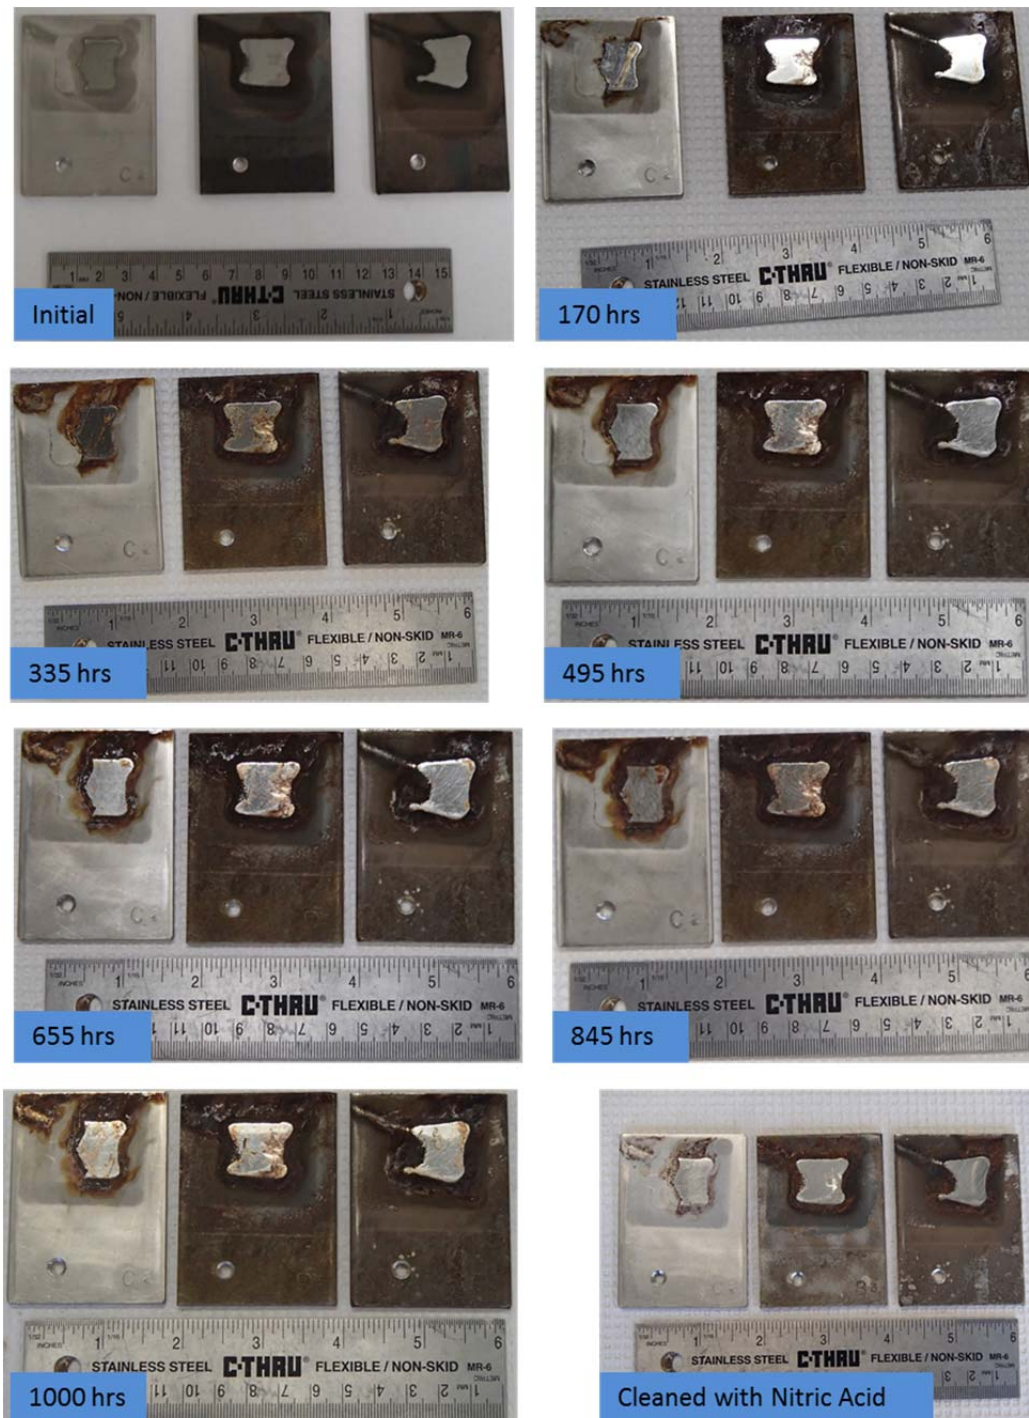
Figure 82. 5001 Group 1 Photographs. As sprayed (left), 950°C/1 hr (center), 800°C/2 hrs (right).

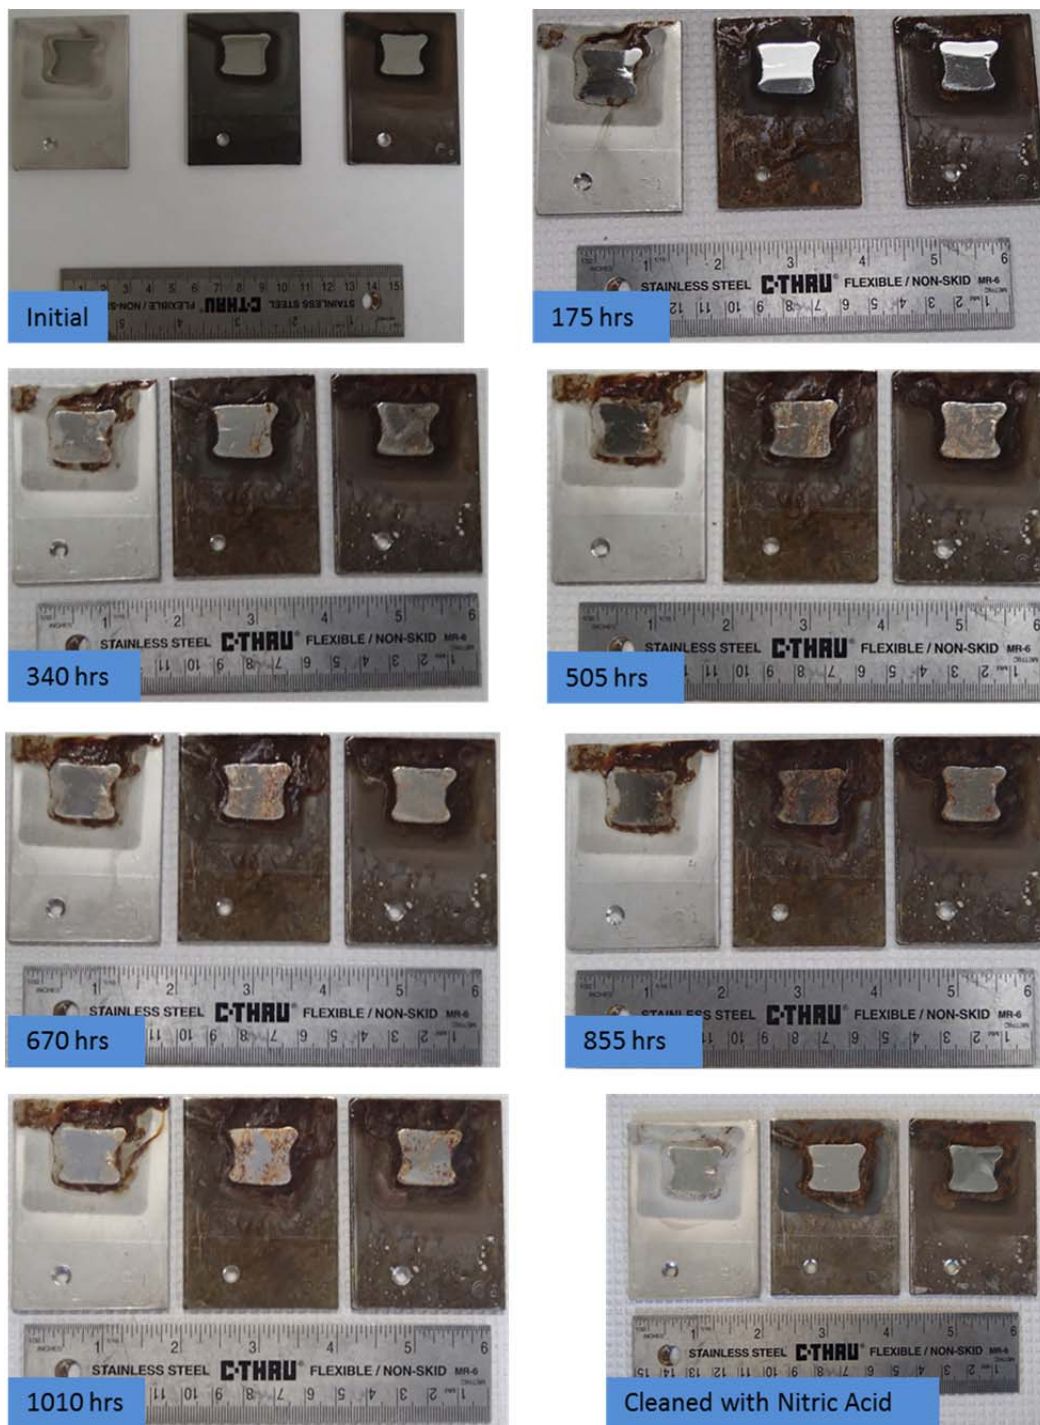
Figure 83. 5001 Group 2 Photographs. As sprayed (left), 950°C/1 hr (center), 800°C/2 hrs (right).

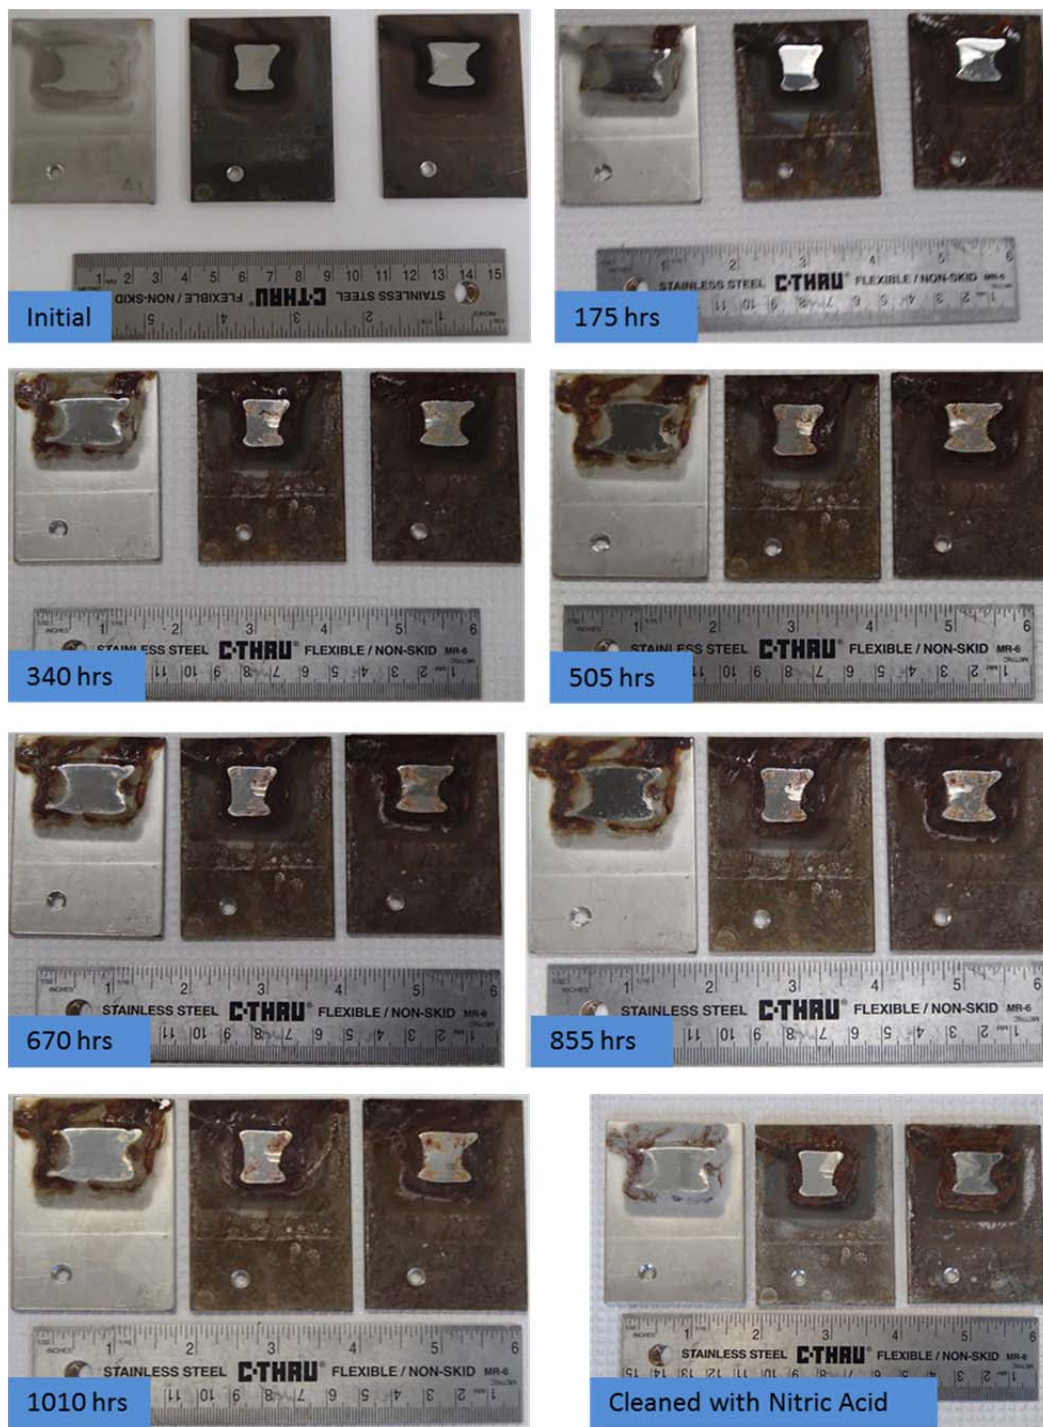
Figure 84. 5001 Group 3 Photographs. As sprayed (left), 950°C/1 hr (center), 800°C/2 hrs (right).

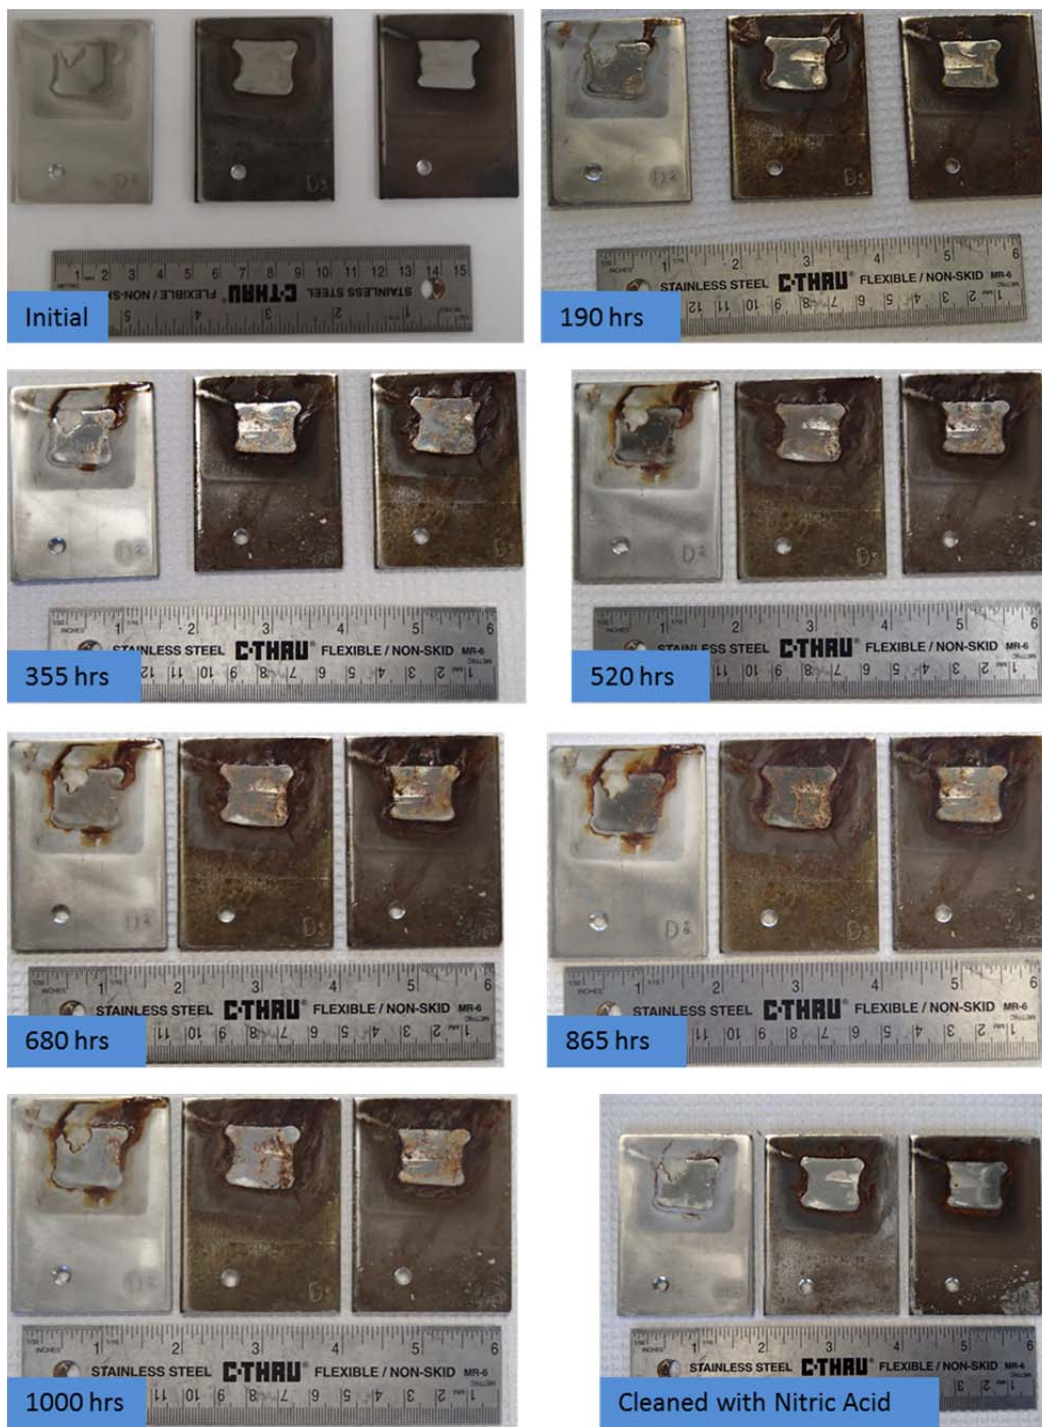
Figure 85. 5002 Group 1 Photographs. As sprayed (left), 950°C/1 hr (center), 800°C/2 hrs (right).

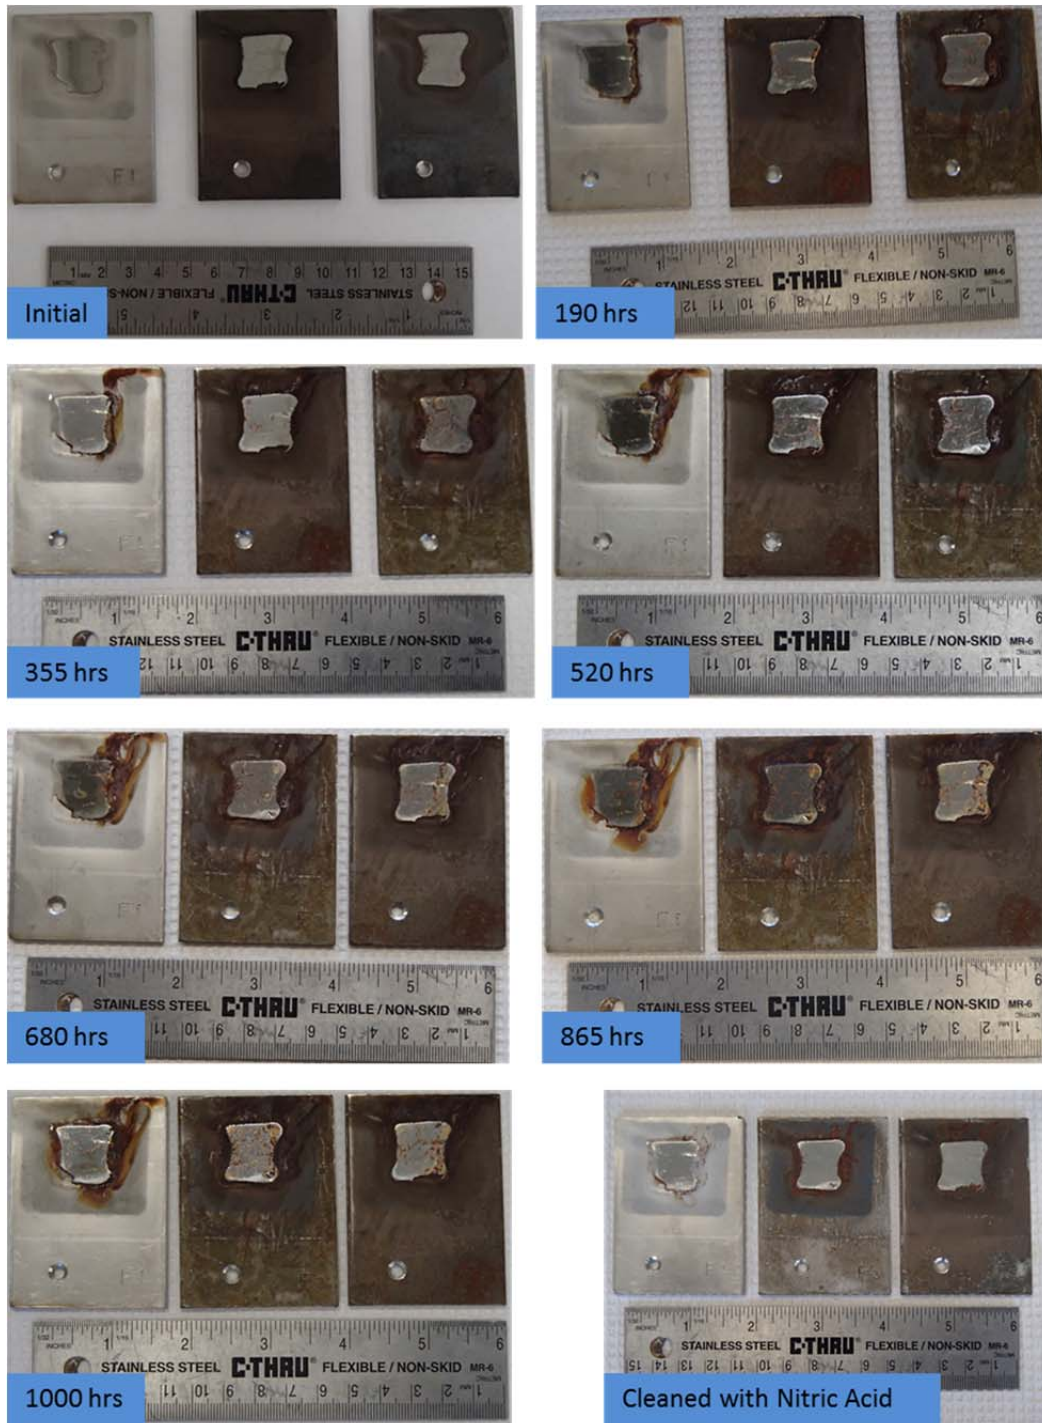
Figure 86. 5002 Group 2 Photographs. As sprayed (left), 950°C/1 hr (center), 800°C/2 hrs (right).

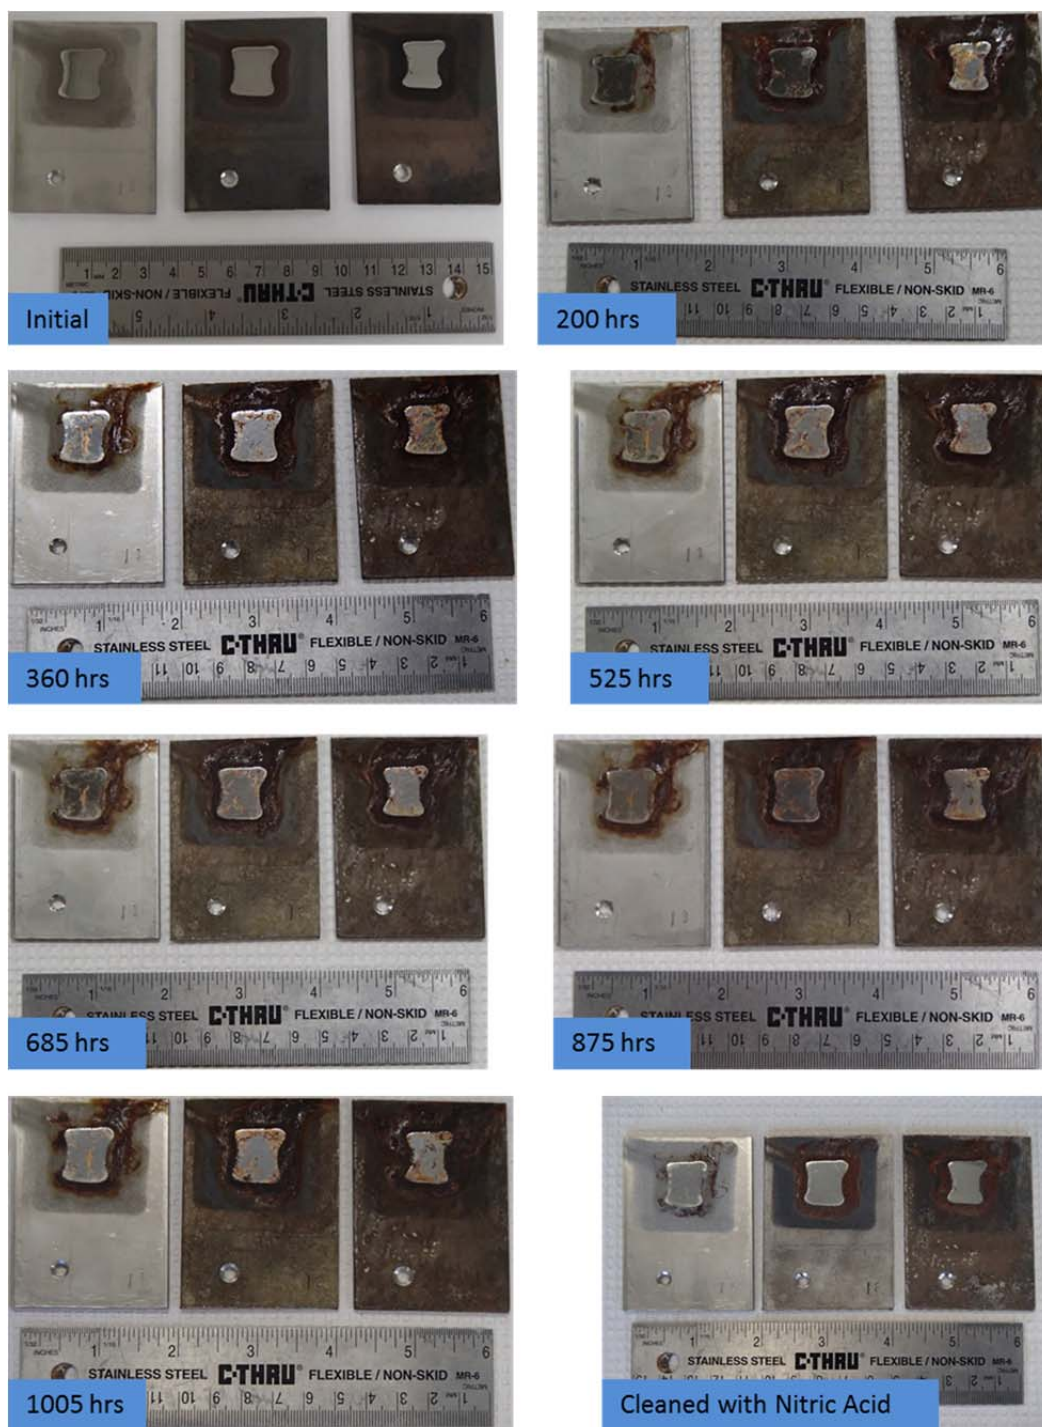
Figure 87. PG-AMP-10 Group 1 Photographs. As sprayed (left), 950°C/1 hr (center), 800°C/2 hrs (right).

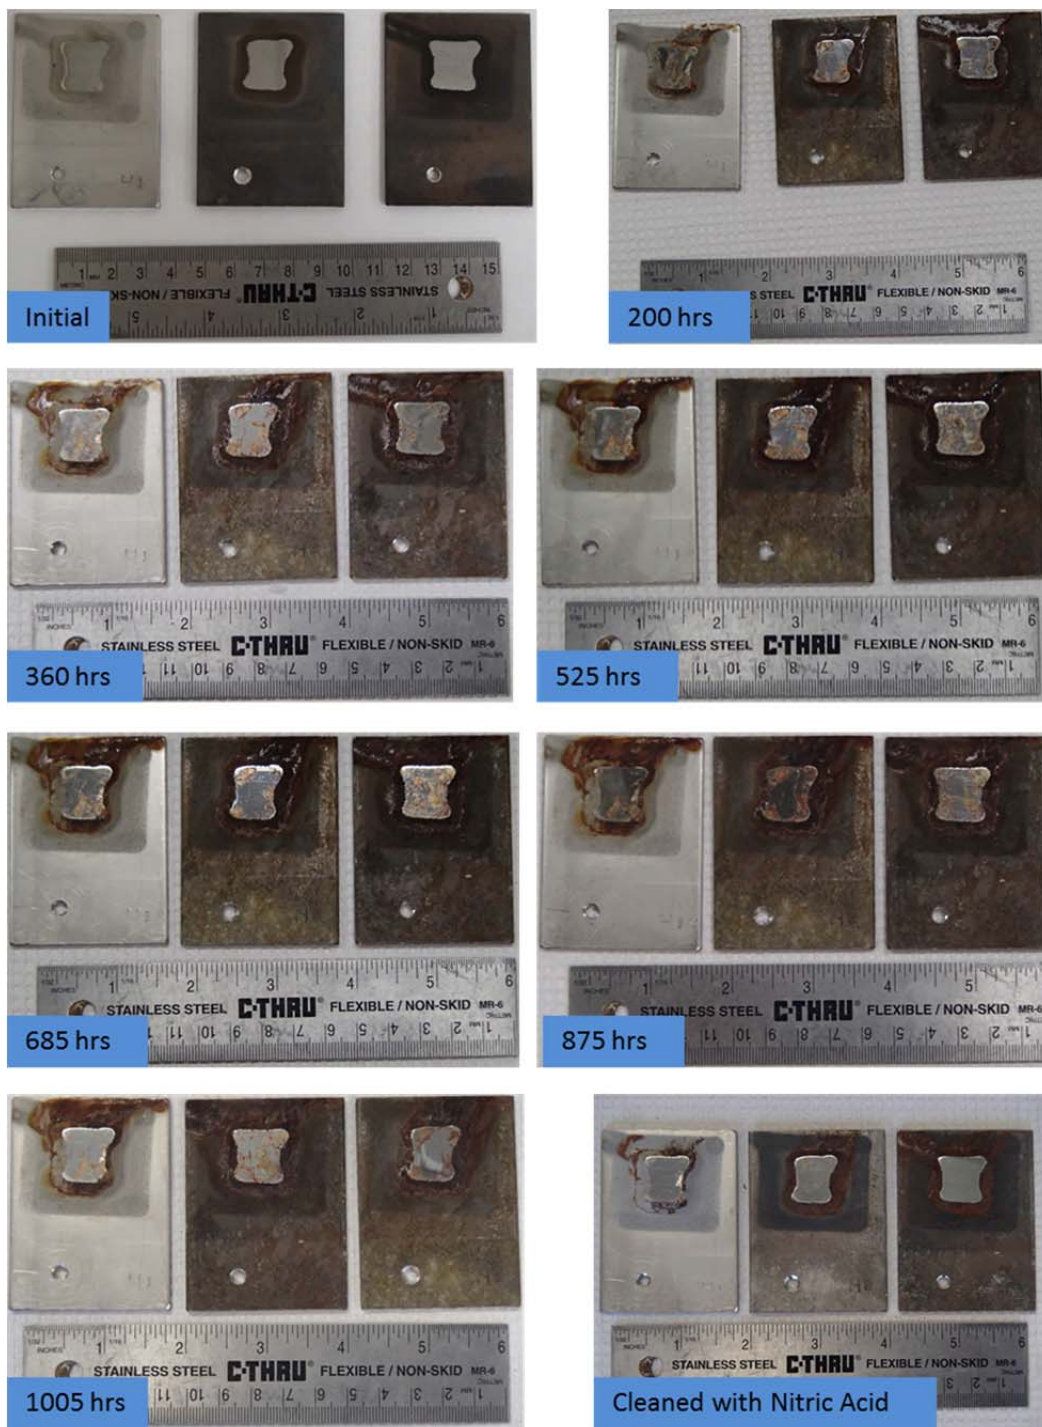
Figure 88. PG-AMP-10 Group 2 Photographs. As sprayed (left), 950°C/1 hr (center), 800°C/2 hrs (right).

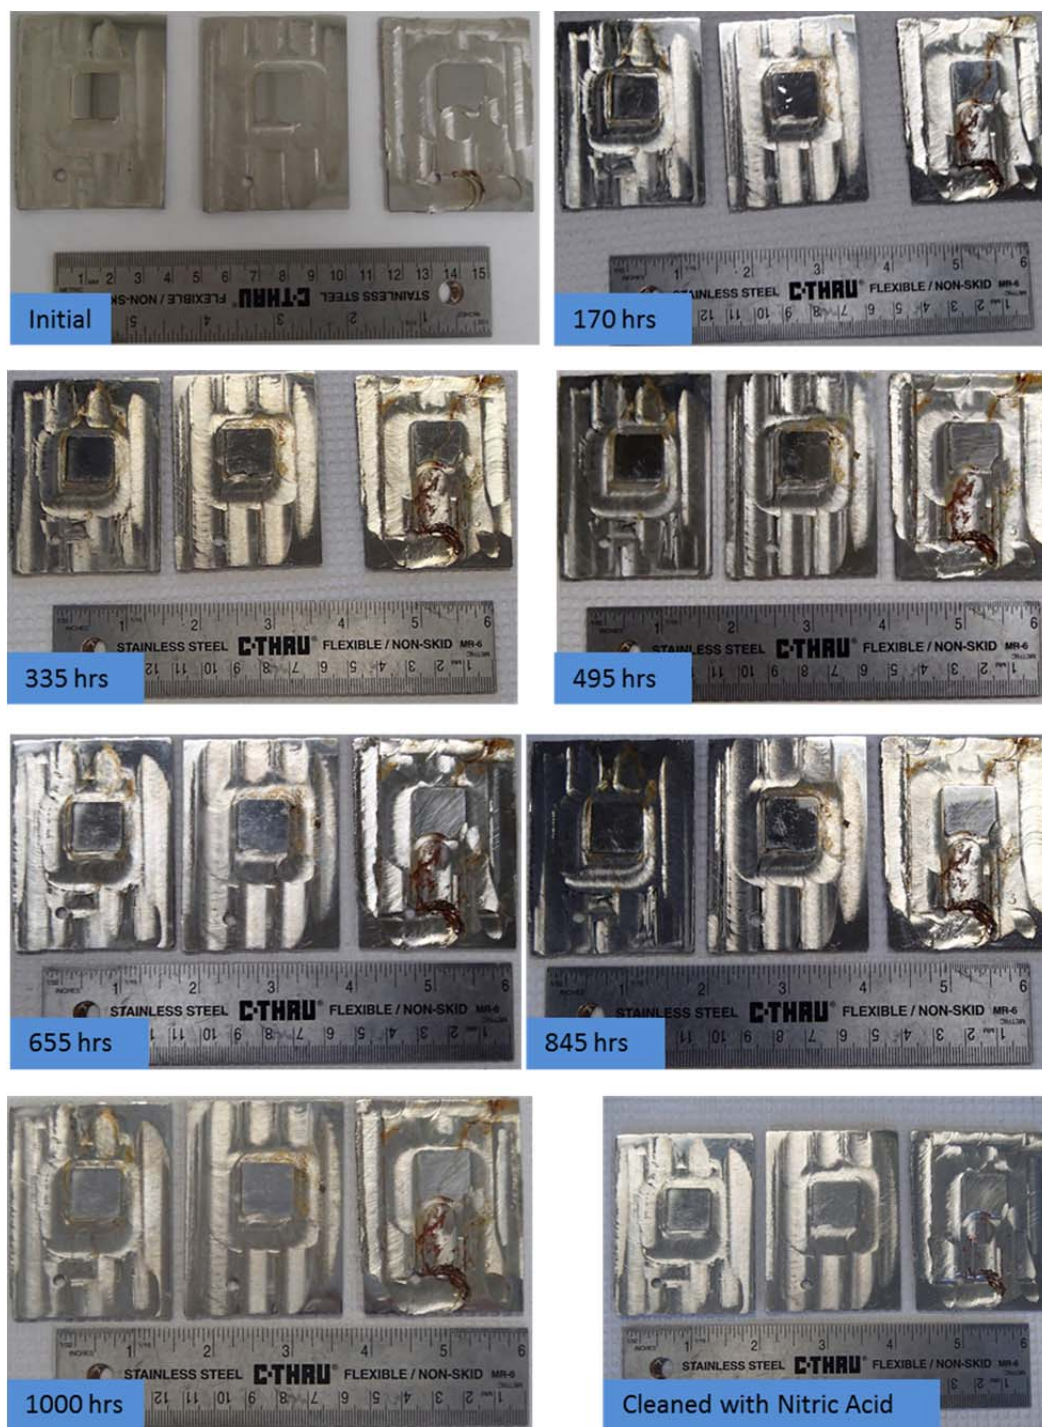
Figure 89. Bare Substrate Photographs. As sprayed (left), 950°C/1 hr (center), 800°C/2 hrs (right).
